Manhole Inspection Summary

Manhole # S13YY1013MH

Insp Date: **7/25/06 11:06 AM**

Location Address: **2214 W ROGERS AVE**

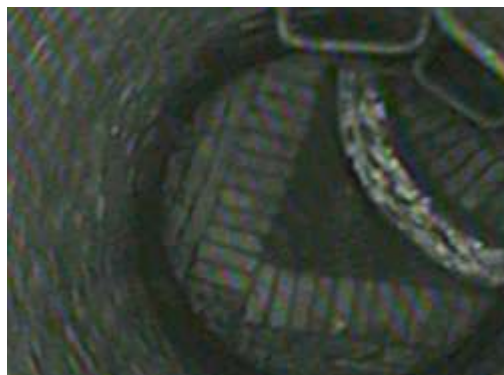
Top View

Corroded steps.

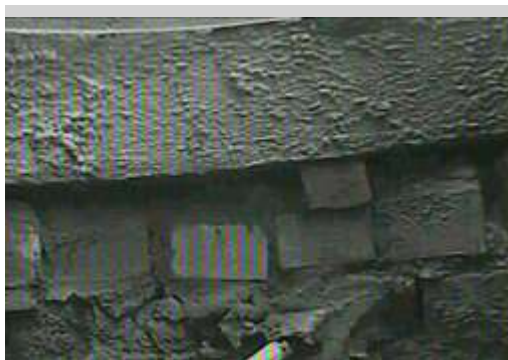
Defect

Frame leaks. Adjustment deterioration, loose brick, and infiltration.

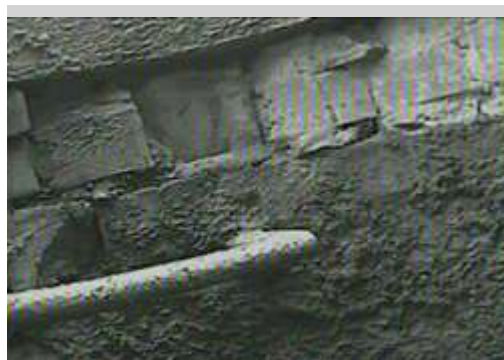
Defect

Frame leaks. Adjustment deterioration and infiltration.

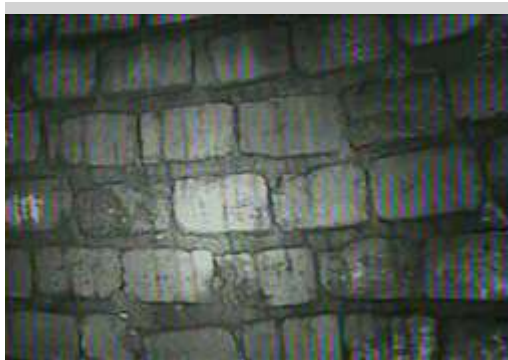
Defect

Barrel infiltration.

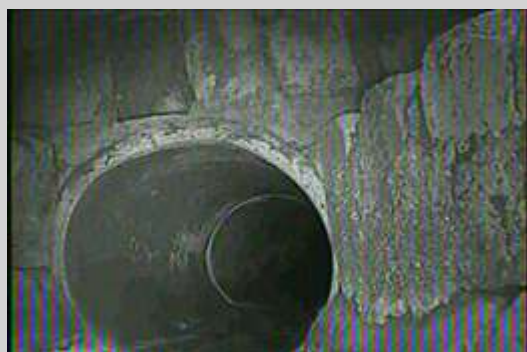
Pipe Out @ 12 O'Clock

Infiltration: **Evidence**

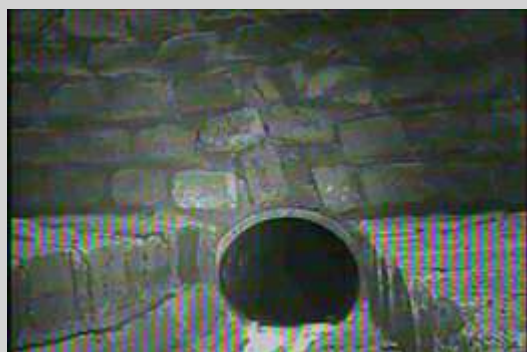
Pipe In @ 3 O'Clock

Channel deterioration.
